## The influence of riparian management on stream erosion

*Ian Rutherford (edited by Phil Price)*

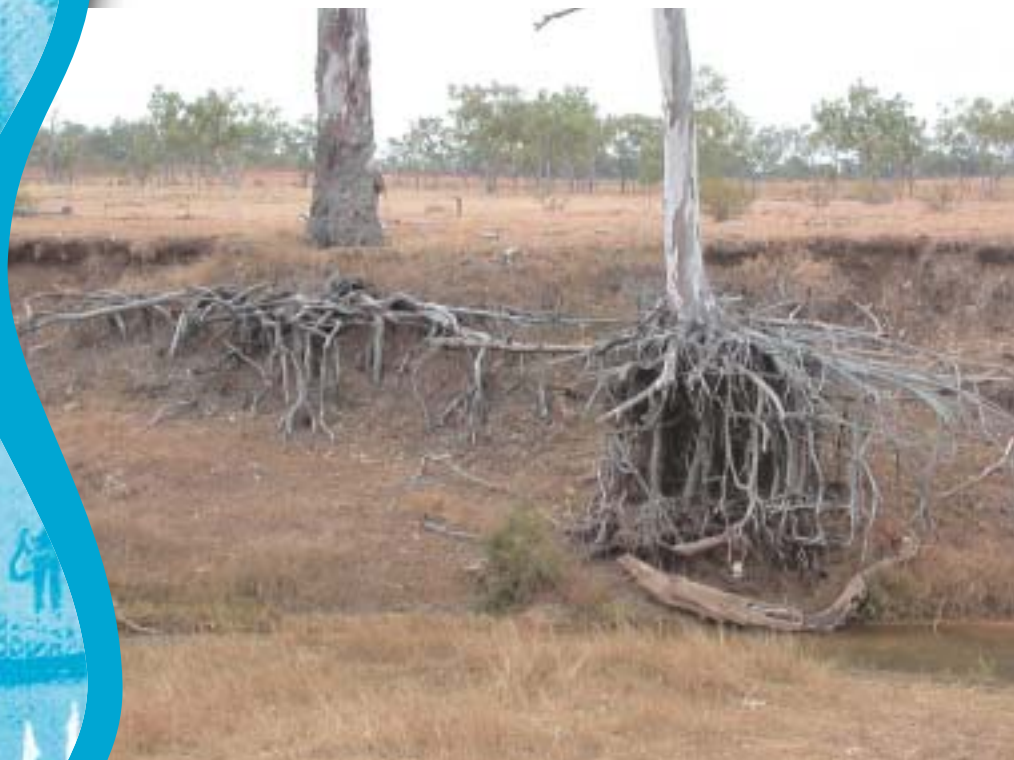
The tree roots show how much soil has been lost by erosion.  
Photo John Dowe.

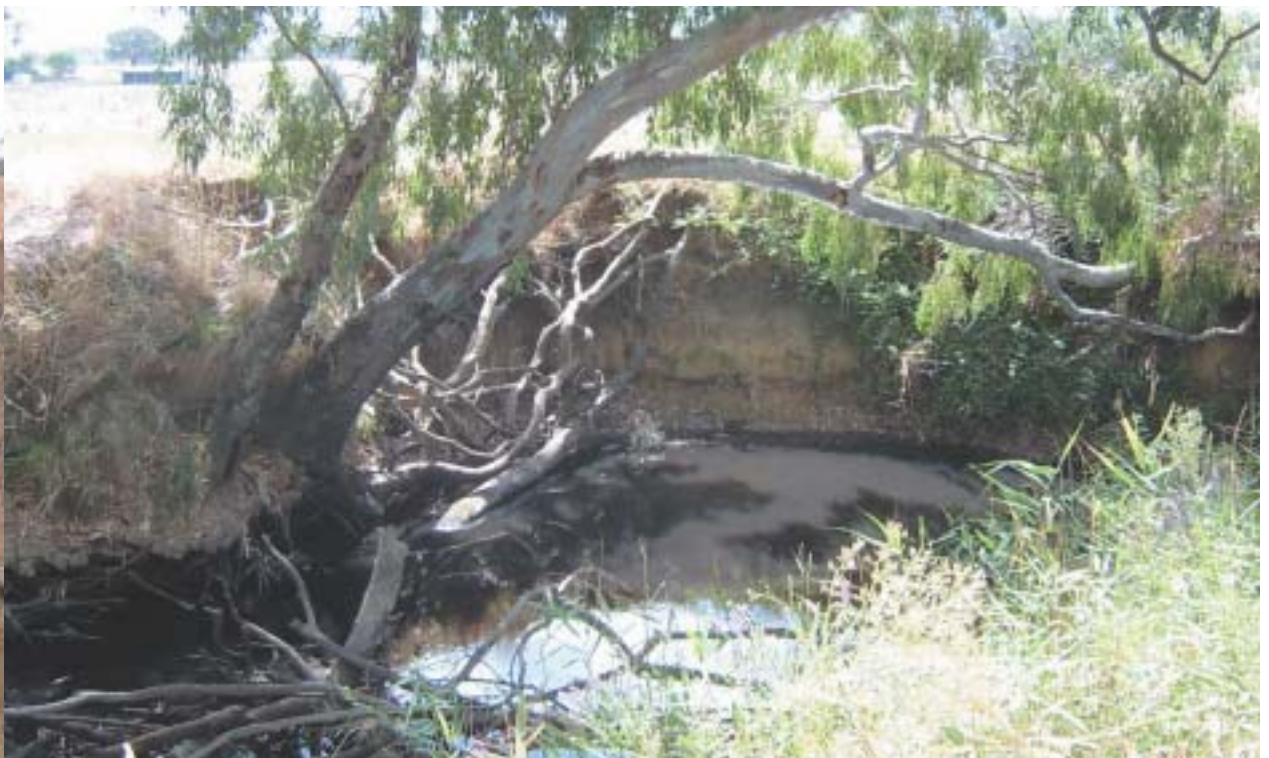
In-channel wood can provide valuable protection to an eroding bank toe and provide an opportunity for natural or planted revegetation.  
Photo Gary Caitcheon.

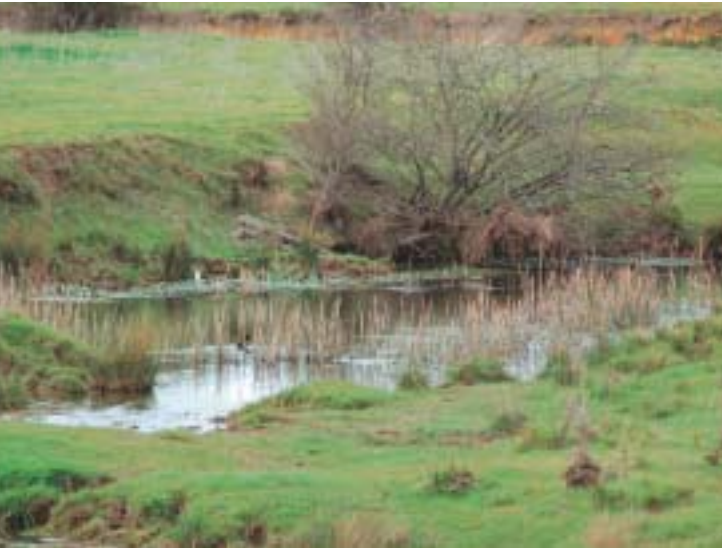
**Channel type 1.** A typical small upland stream. Photo Roger Charlton.

#### 1. Small upland tributaries (1st to 3rd order streams)

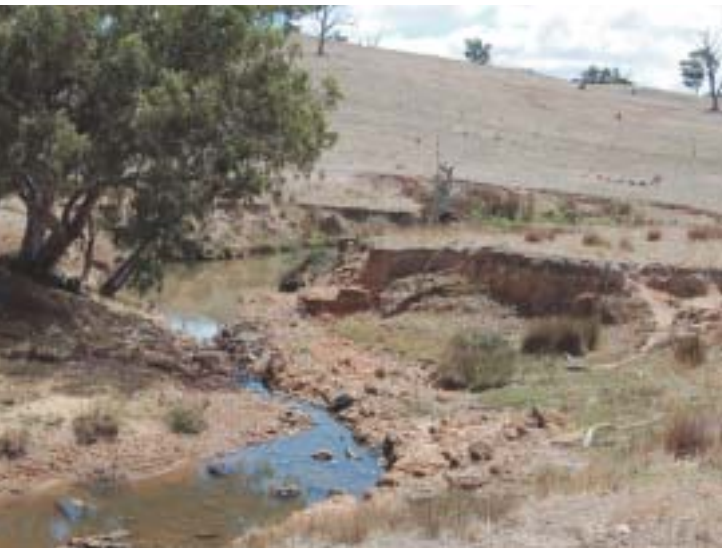
**Channel type 2.** A small but active gully. Photo Roger Charlton.

#### 2. Gullies

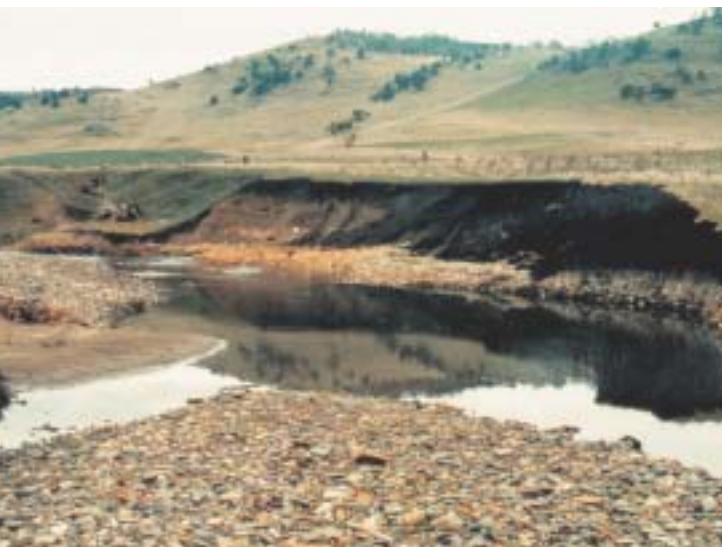
**Channel type 3, below:** Typical of many incised streams in rural landscapes. Photo Biz and Lindsay Nicolson.

#### 3. Incised streams

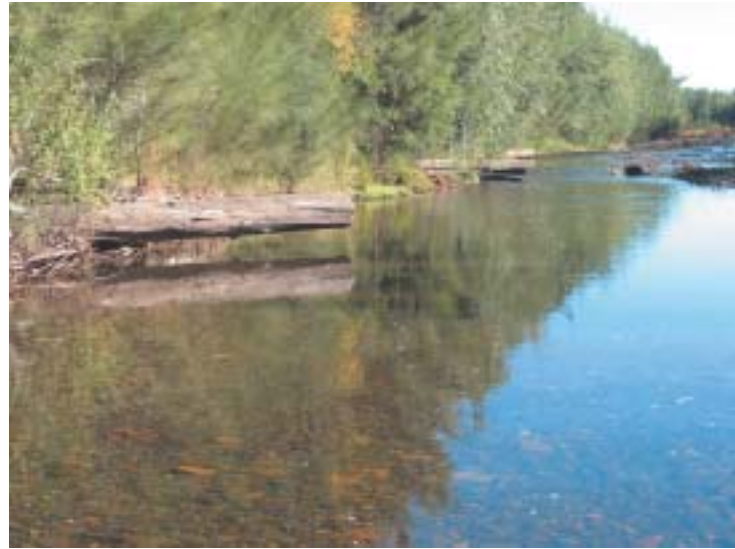
**Channel type 4.** Photo Andrew Brooks.

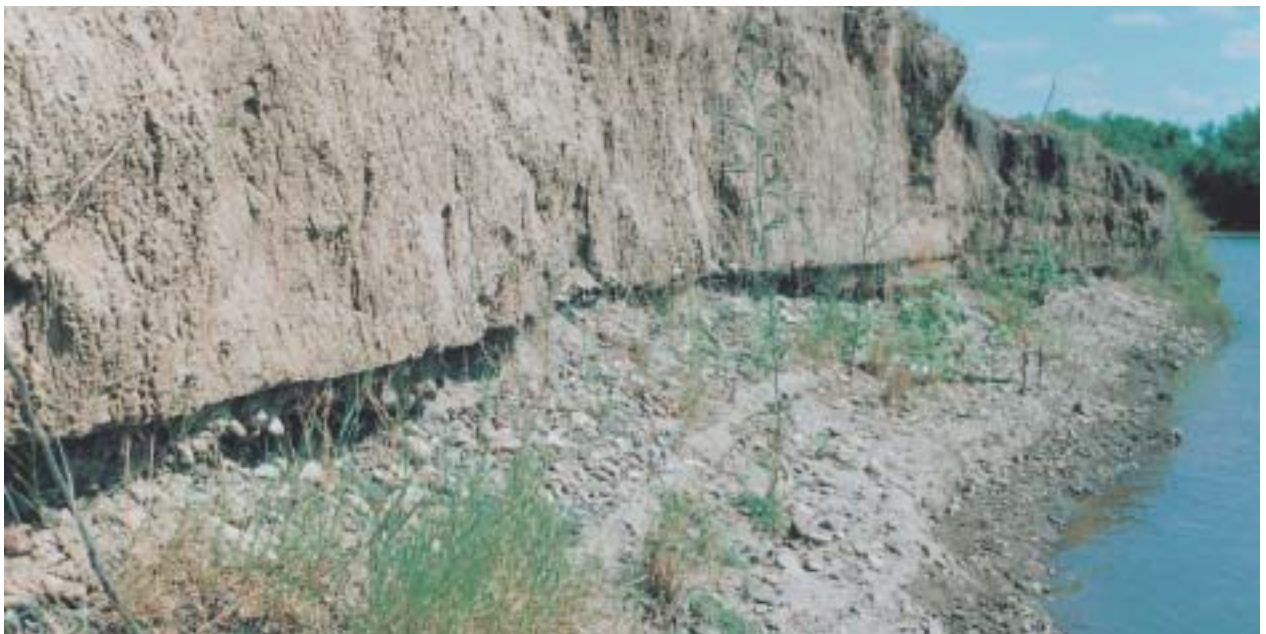
Fluvial scour at the high water toe of a bank. Photo Guy Roth.

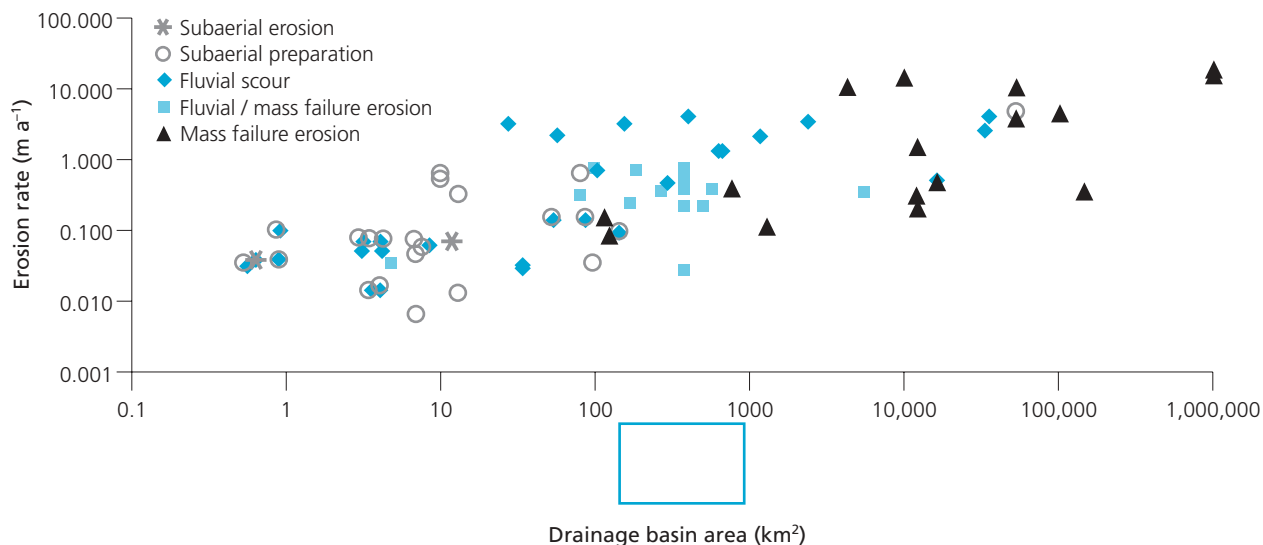
**Figure 6.2.** Relationship between different erosion processes and catchment area (based on a review of global data by James Grove). The blue rectangle shows the erosion domain for the Kiewa River described below.

Erosion rates on the Kiewa River are about one tenth of the global averages for a stream with its catchment area (Figure 6.2), ranging from 50 to 200 millimetres of bank retreat per year (Figure 6.4, overleaf). There is also a strong positive relationship between the size of the stream and erosion rates (Figure 6.4). Mass failure was the dominant erosion mechanism in the catchment as a whole, accounting for two thirds of all erosion in the period:

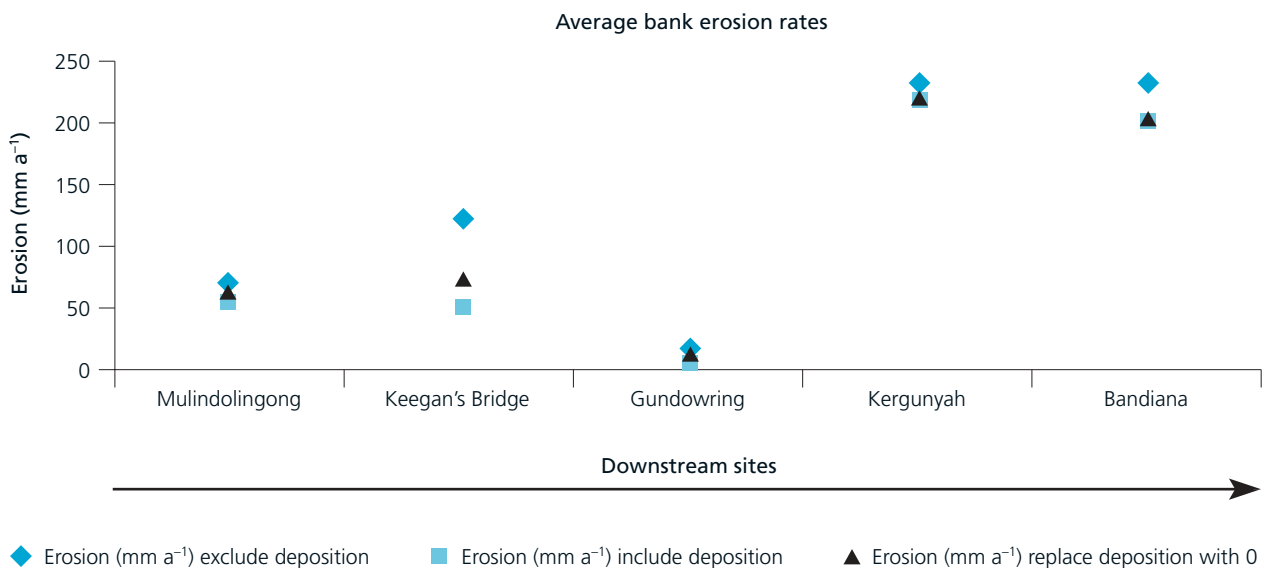
**Figure 6.4.** Average bank erosion measurements (over the full bank face) at the five sites, over four years of measurement (three sets of erosion measurement are shown, one taking no account of deposition at the site, one subtracting from the measured erosion any deposition, and one using zero for deposition in calculating averages).

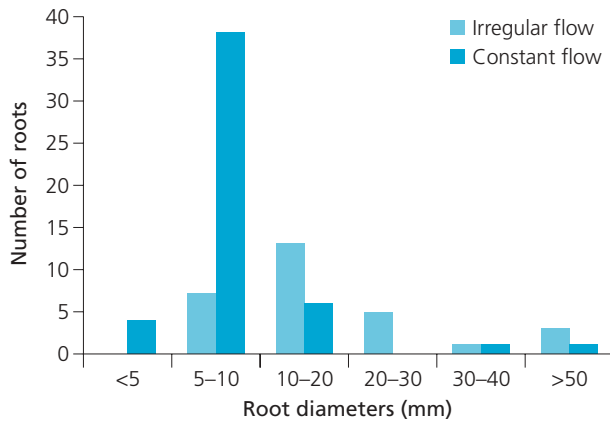
**Figure 6.6.** Distribution of roots in sites with constant and irregular flow regimes.

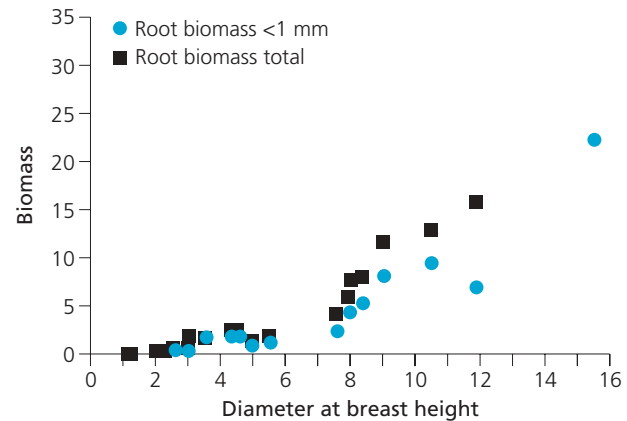
**Figure 6.7.** Root biomass increases at about the same rate as the size of the tree (diameter breast height).

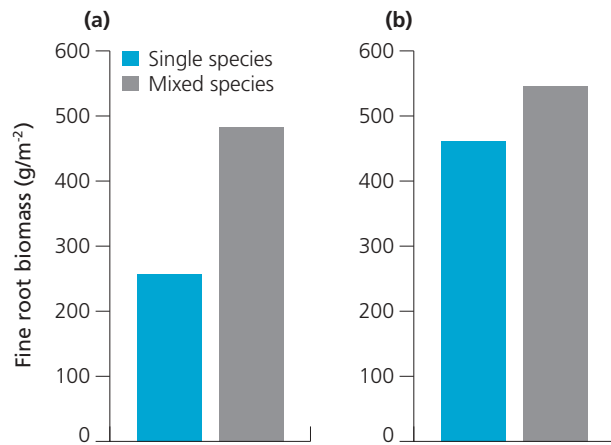
**Figure 6.8.** Example from North America showing that species in competition have relatively more roots than species that are not in competition. The right hand graph (b) shows a lighter soil than the left hand graph (a), demonstrating the effect of soil clay percentage.

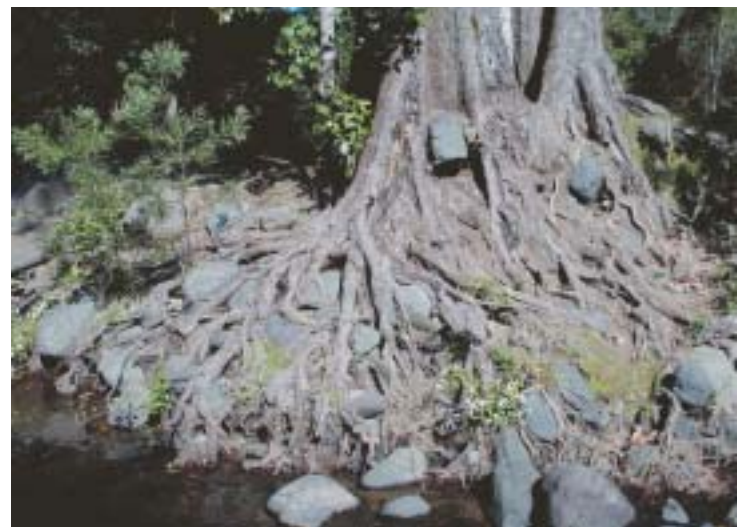
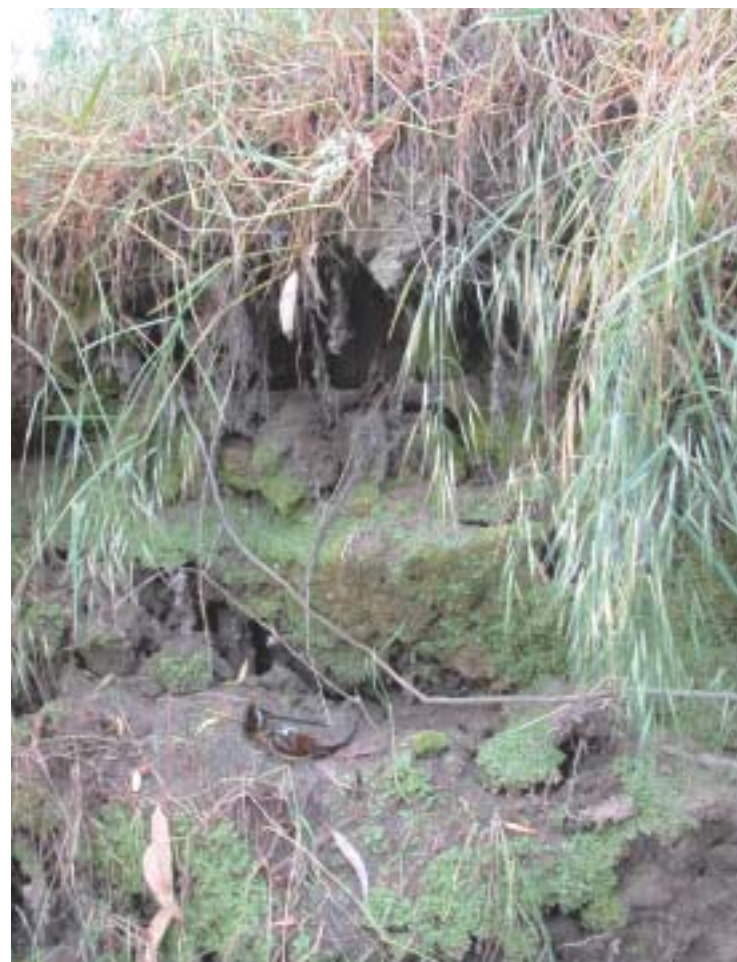
Two examples of plant roots growing within and on the surface of a streambank. Photos: (above) Andrew Brooks, (below) Ian Rutherford.

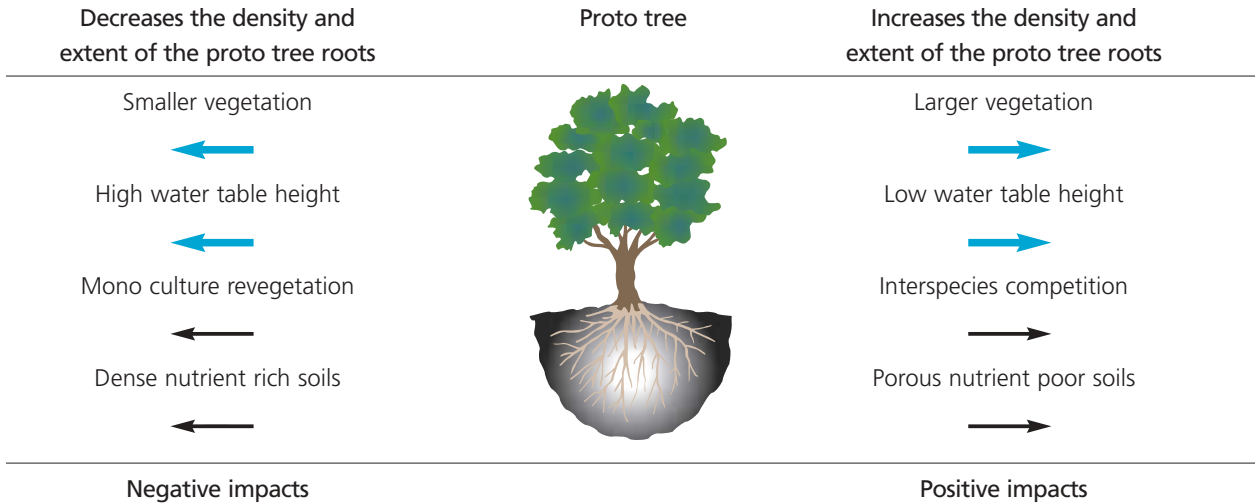
**Figure 6.9.** The ‘proto’ tree and the impacts of site conditions that affect root architecture and density are identified with their effects on the root distribution and density of the proto tree.

From these points it is possible to understand the processes and conditions that affect root architecture and its influence on mass failure for a 'proto tree', or typical riparian tree, in a temperate environment. The basic measure of the effect that tree roots have on mass failure is increasing the Apparent Cohesion ( $C_a$ ). The apparent cohesion will vary with RAR (Root Area Ratio) root density, root length, root volume and biomass of a proto tree if all other bank properties remain the same. The significance of the different site conditions that will influence vegetation and root growth and structure are summarised in Table 6.2. The most important variable

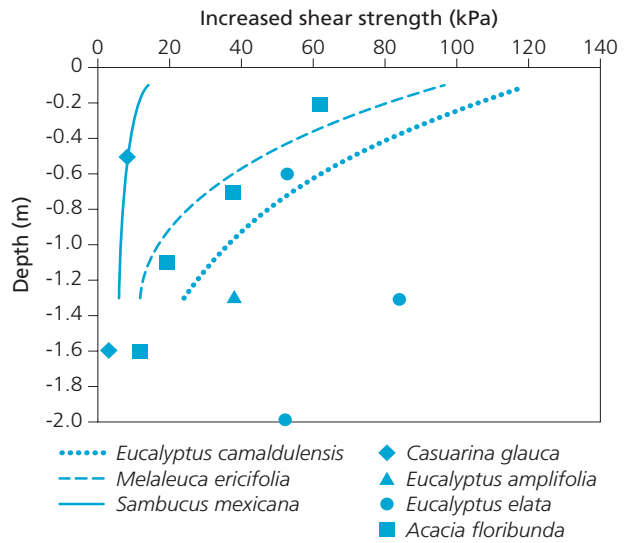
**Figure 6.10.** Data comparing increased shear strength from various riparian tree species.

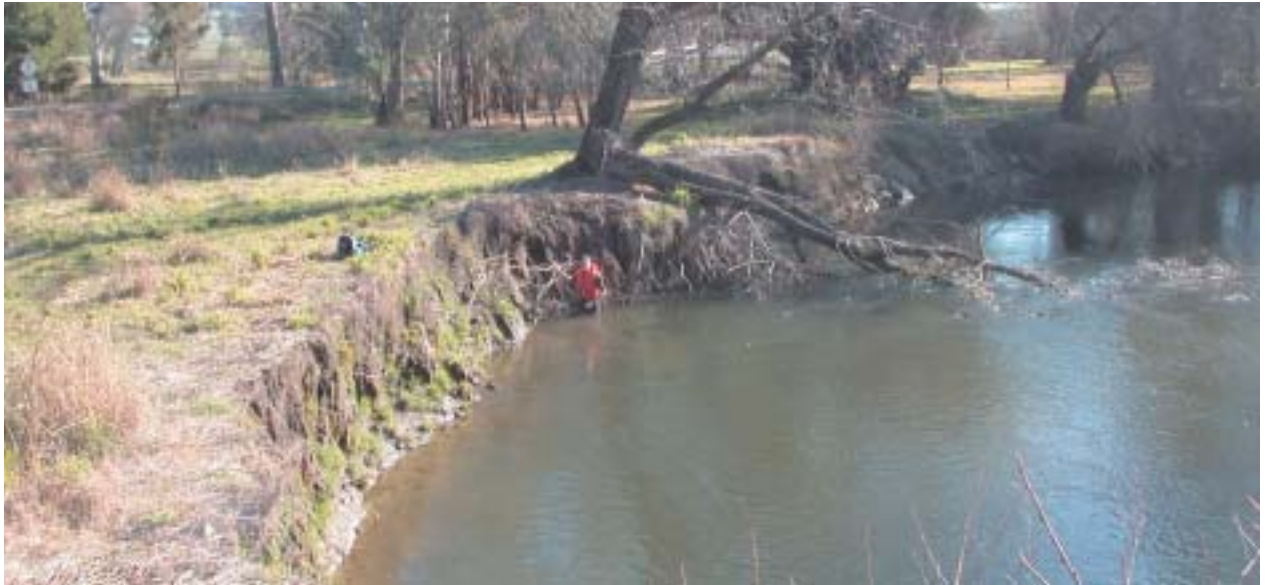
A typical abutment, but lone trees are eventually outflanked by erosion. Photo Ian Rutherford.

2. All abutments are deeply undercut, with most of the abutment formed of a 0.5 to 1 metre thick overhanging plate of finer sediments reinforced by roots. However, the deviation of the bank curve at the toe of the bank below trees, indicates that they also provide some strengthening of the bank at the toe, even when the bank is nearly 4 metres high. This strengthening is not enough to materially alter the migration rate of a meander bend. Abutments fail by toppling.

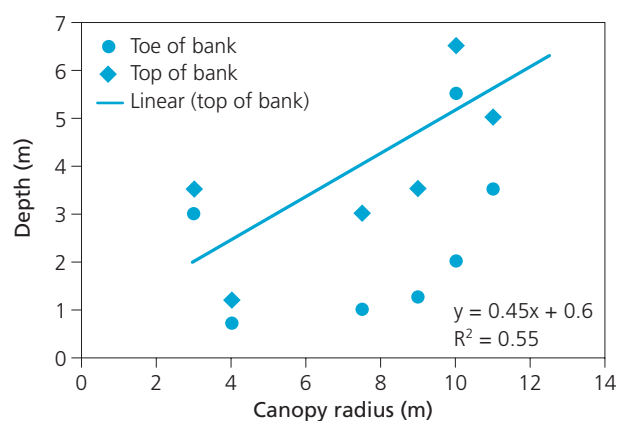
Figure 6.11. Relationship between the radius of the tree canopy (the drip line) and the radius of the abutment along the Acheron River.

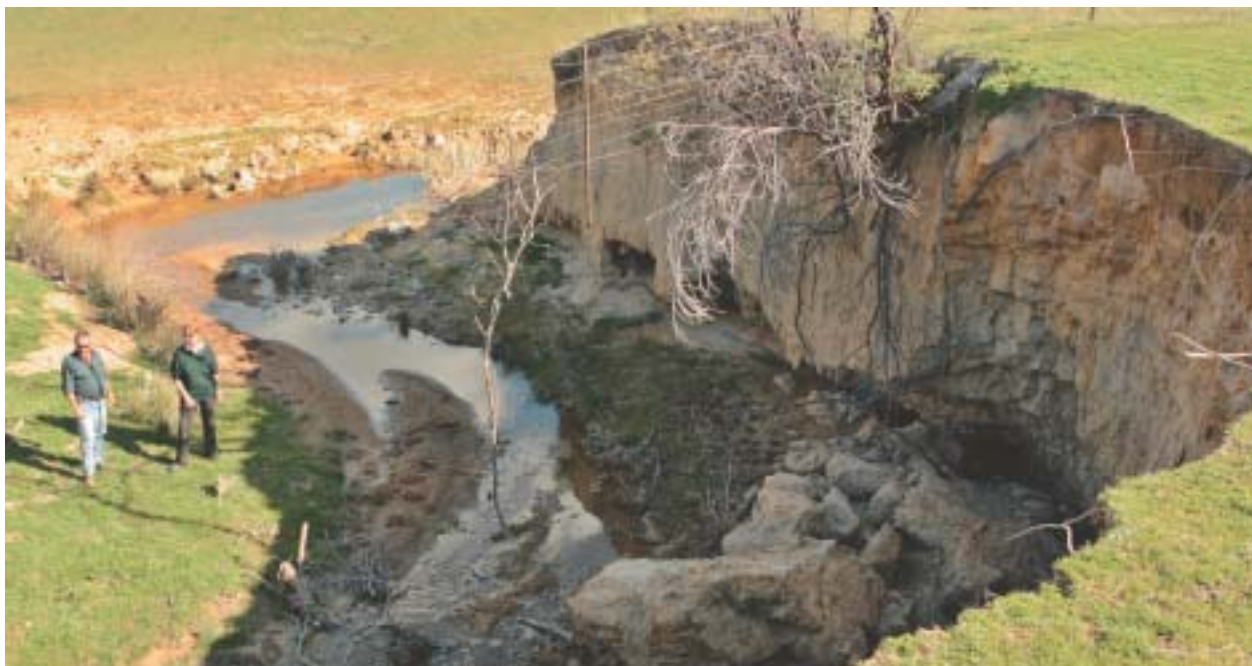
Mass failure following undercutting at an outer meander bend. Photo Gary Caitcheon.

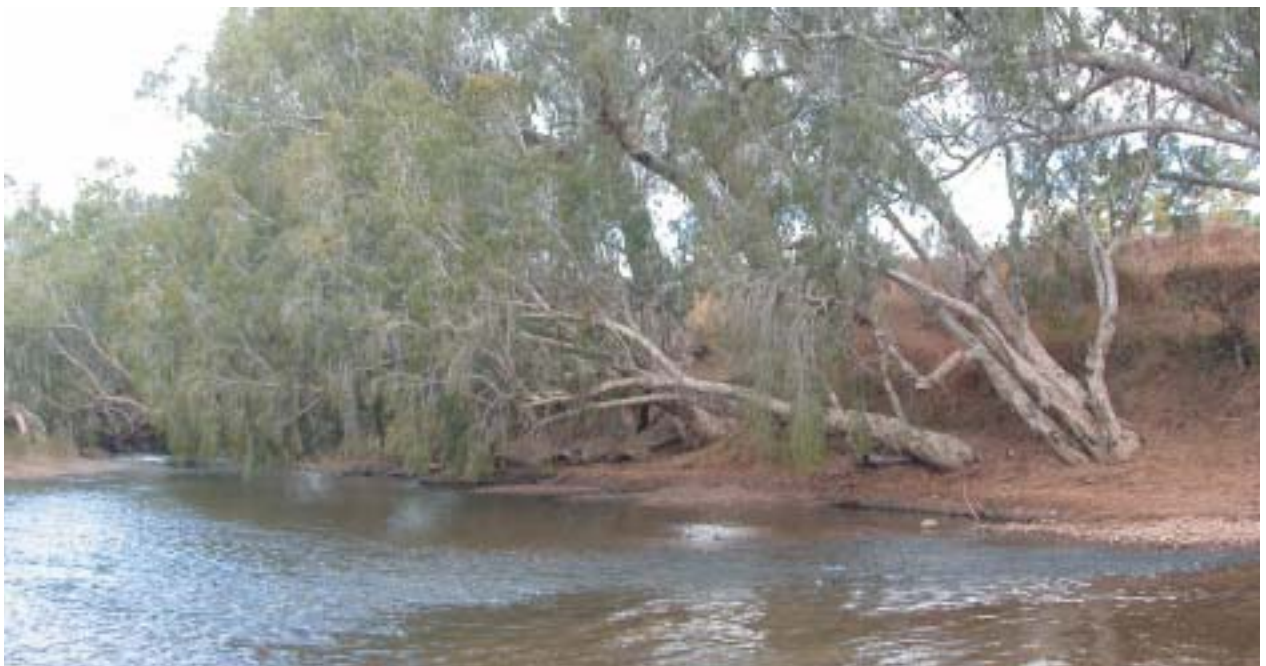
The root masses of *Melaleuca fluviatilis* protect and reinforce this streambank. Photo John Dowe.

Although root densities are highest close to the soil surface, the full reinforcement potential of the roots may not be realised unless they penetrate to depth. However, roots may pull out of the soil before their peak strength is reached. Longer and more firmly implanted roots provide greater reinforcement than do their shorter and loosely anchored, but equally strong, counterparts. Hence, trees provide more reinforcement to the general stability of a river bank than do shallow-rooted grasses.

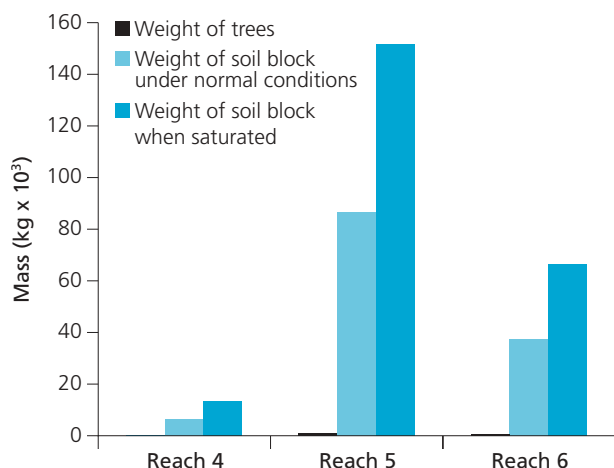
**Figure 6.12.** Surcharge from wattle trees along three reaches of the Latrobe River (from Abernethy & Rutherford, 2000a).

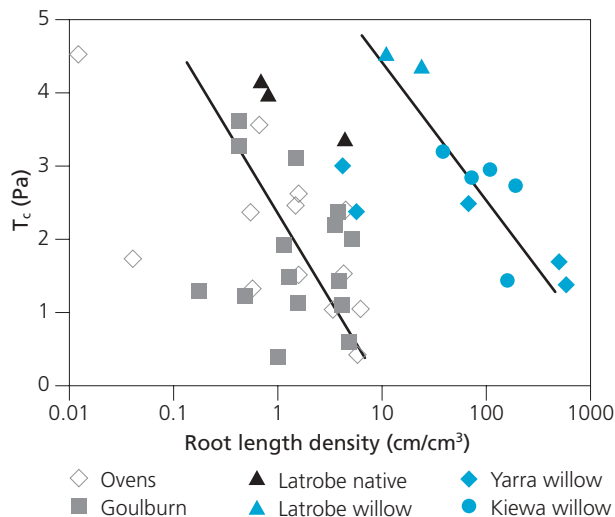
**Figure 6.13.** Critical shear stress (measured by the hydraulic jet device) required to erode sediment with different root length densities (measured by the root scanner device).

The result for willow roots is also interesting. We found that willow roots do not have a particularly higher critical shear stress than do the roots of native trees. This is surprising as willow roots are very dense, and in experiments have always been found to be resistant to erosion. The reason that we appear to find modest erosion

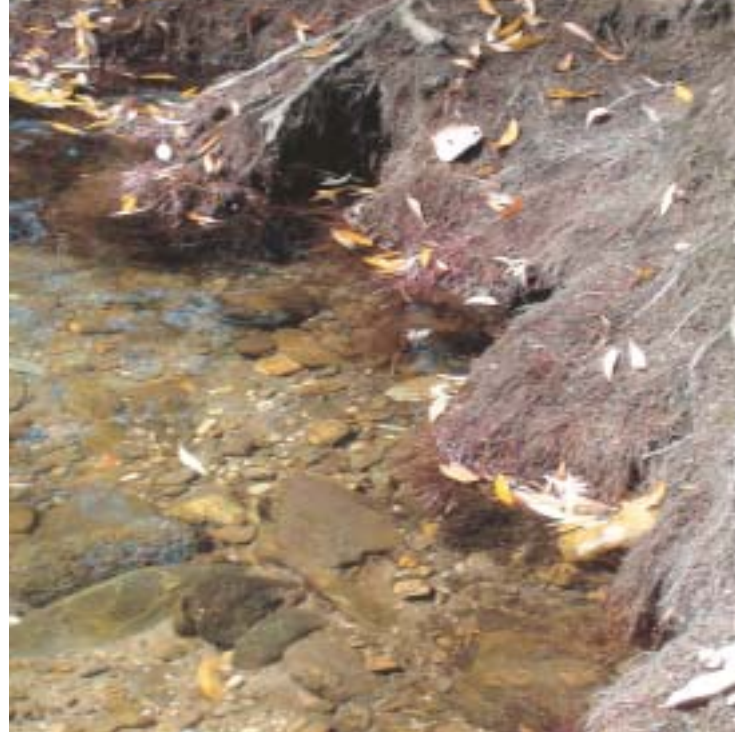
Fluvial scour underneath a willow root mat. Photo Lizzie Pope.

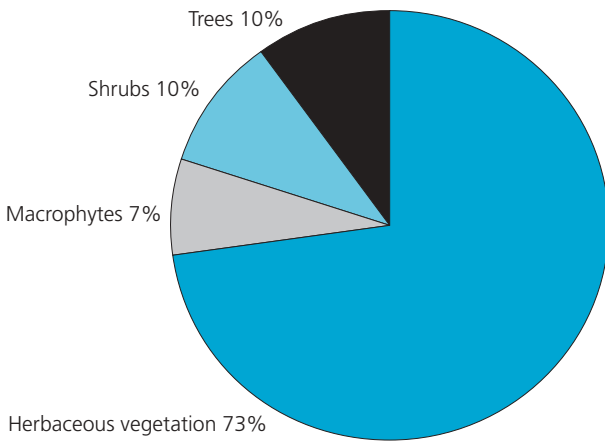
**Figure 16.14.** Occurrence frequency of vegetation types on vegetated horizontal surfaces in Victorian streams (percentage of vegetated horizontal surfaces with each type of vegetation).

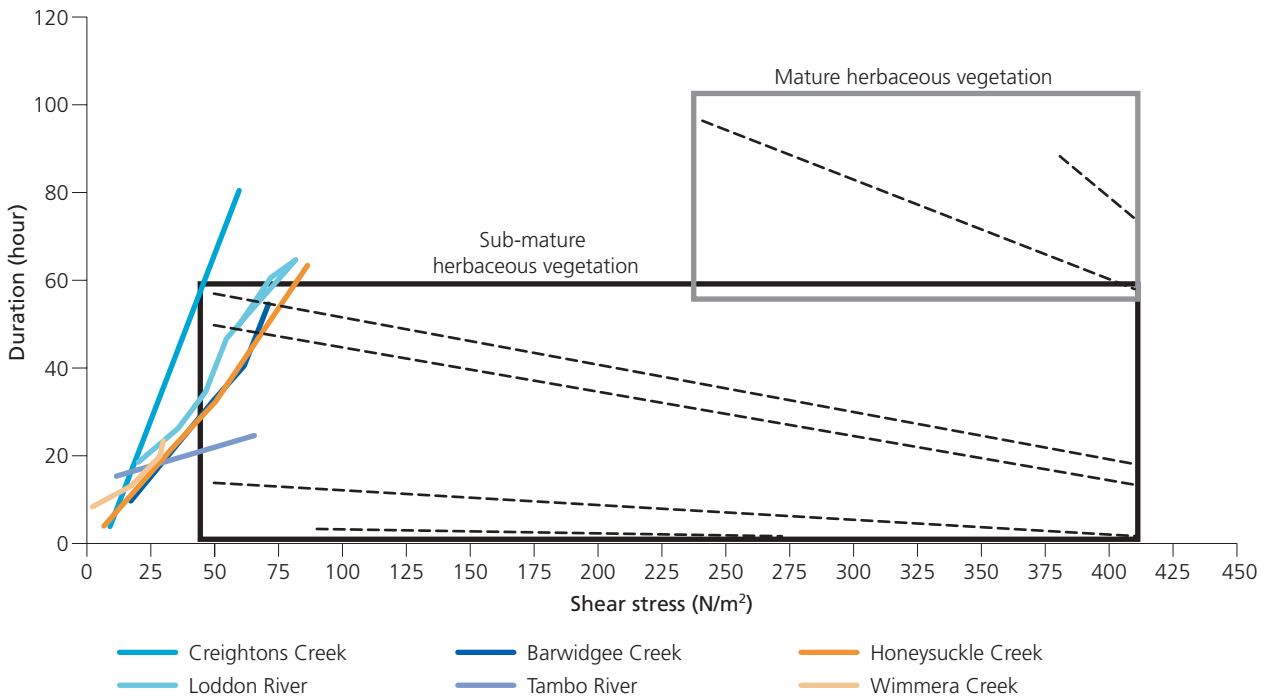
**Figure 6.15.** Summary graph showing erosion prediction analyses for all combinations of tested herbaceous vegetation and substrate at each study site (the coloured lines show the shear stress and duration of flows experienced in the streams listed, the black dashed lines show the duration and resistance curves from the flume data). The black framed box shows that erosion resistance curves for mature herbaceous vegetation on silt/clay and sandy gravel substrates generally exceed stream conditions and are resistant to erosion. The grey framed box shows erosion resistance curves for medium and short herbaceous vegetation on silt/clay and sandy gravel substrates are generally less than conditions experienced in streams, so this vegetation is likely to erode under the more extreme conditions.

The implications of this research are that grass is tremendously effective at stabilising stream beds if it is able to grow to maturity, and particularly if it is not grazed.

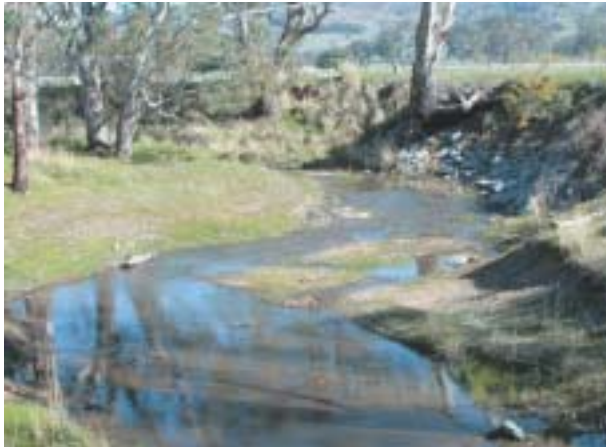
Grassed bars in an incised stream. Such grassed bars and benches are common in rural lands. Photo Ian Rutherford.

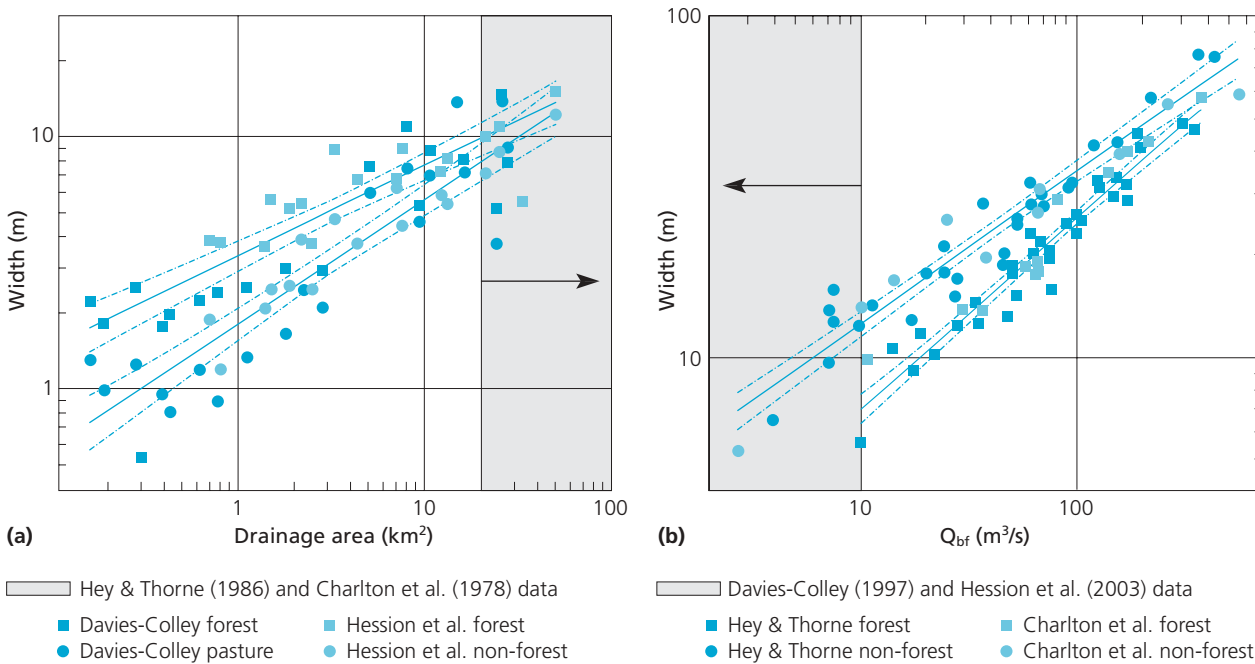
**Figure 6.16.** Graphs of data from four studies on the effect of vegetation on channel width. Graph (a) shows forested streams with small drainage areas are wider than un-forested streams of the same size. Graph (b) shows that larger forested streams are narrower than un-forested streams with the same discharge (Anderson et al. 2004, p. 1163).

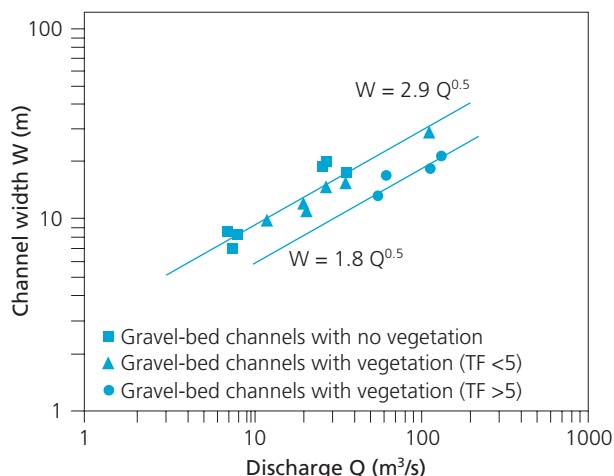
**Figure 6.17.** At a given discharge, channels lined with Australian Native vegetation were found to be narrower than those with few or no trees (Huang & Nanson 1997b, p. 243).

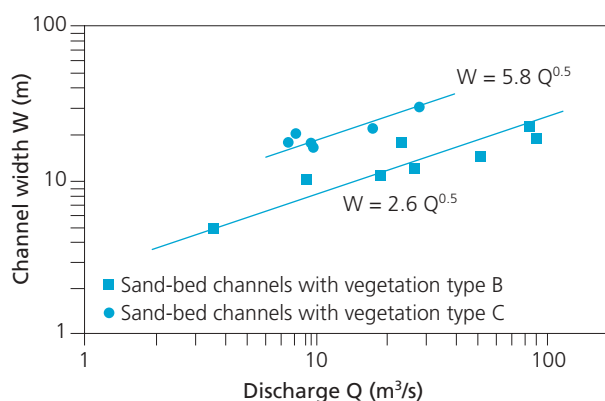
**Figure 6.19.** Graph showing the results from a study on the width of streams with native Australian trees on the bank (Type B), compared to the width of streams with willows on the bed as well as natives on the bank (Type C) (Huang & Nanson 1997b, p. 245).

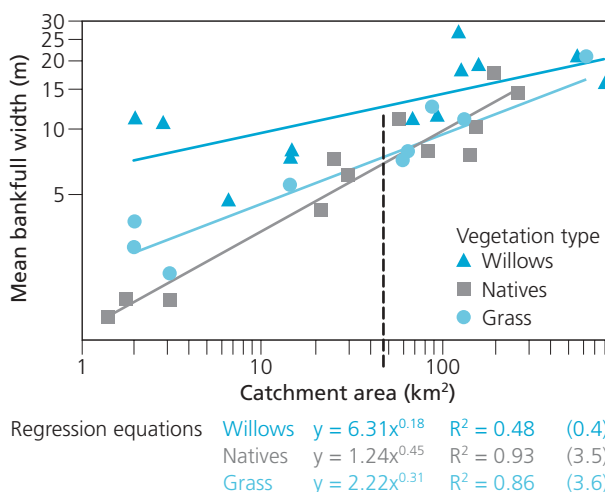
**Figure 6.20.** Scatter plot on log-log scale showing data points and regression lines comparing the mean bankfull width of streams related to catchment area and vegetation type (grass, natives and willows). The dashed line indicates the approximate point at which sites with native vegetation become narrower than those with grass (~60 km<sup>2</sup>).

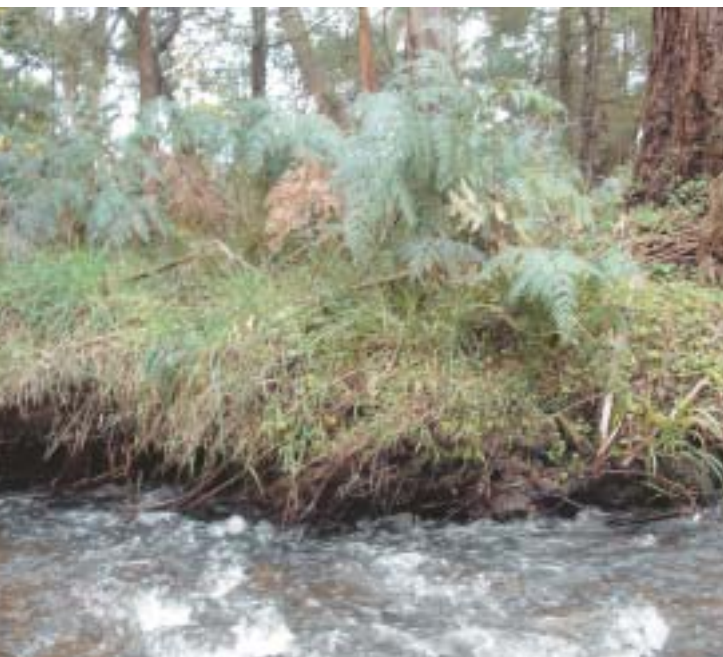
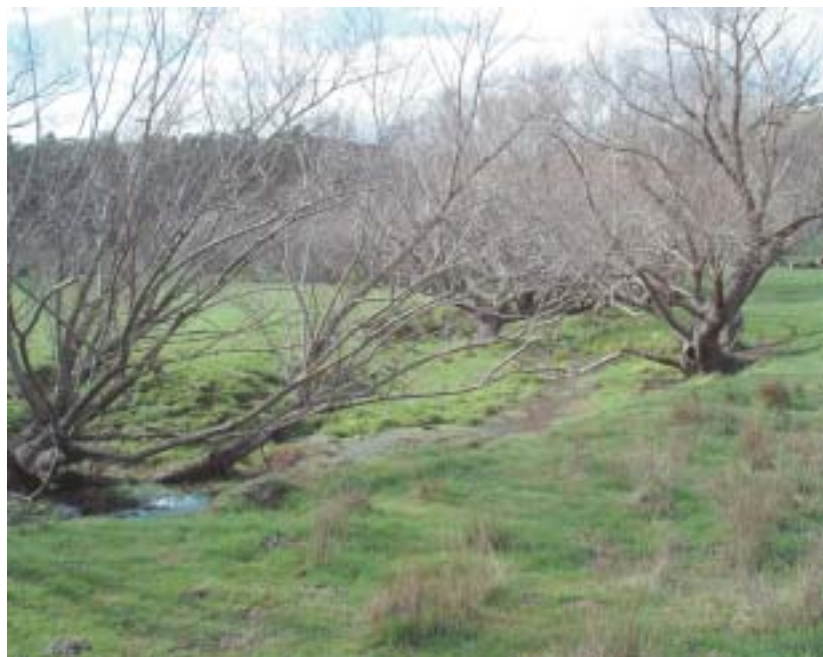
Photos illustrating (left) the dense undergrowth and grass cover found at some field sites with a cover of native riparian trees and (right) the cover of grass present at sites with willows. Photos Ian Rutherford.

2. At sites with native vegetation, the majority of trees were located on the upper bank or on the floodplain. In contrast, at sites with willows almost all trees were located within the channel, either on the lower bank or in the channel bed.

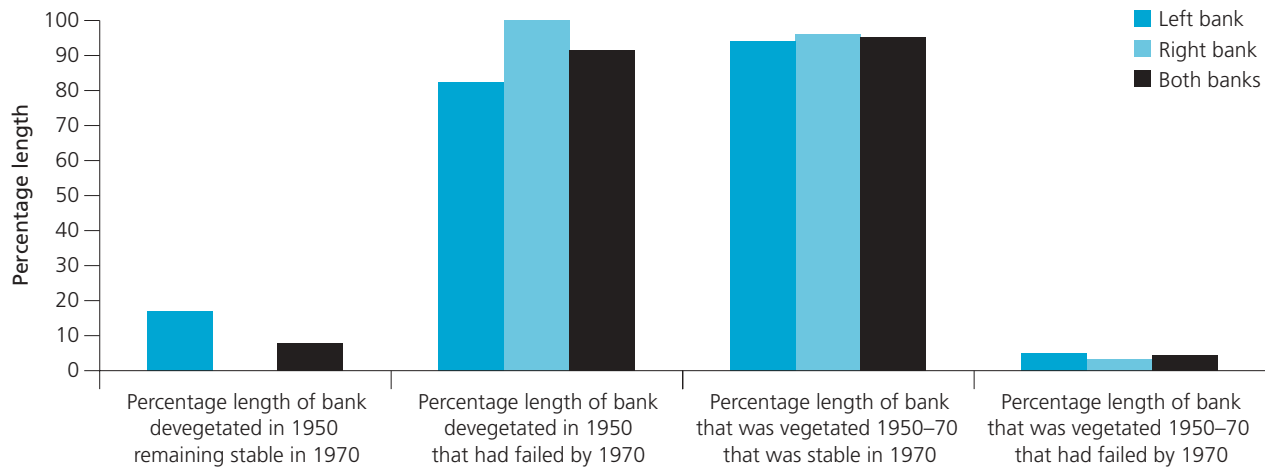
**Figure 6.21.** Bank failure in revegetated and cleared sections of bank in the Nepean River.

The geomechanical stability of eight bank sections on the Nepean River was analysed. Geomechanical models for vegetated and devegetated banks in fully saturated

geo-mechanical results support the hypothesis that both clearing and floods were required to trigger major widening of banks in the Nepean River. This result does not say that the same is true for all rivers that suffered major widening over the last 150 years, but it does suggest that clearing of riparian vegetation is almost certainly a factor in much of this widening.

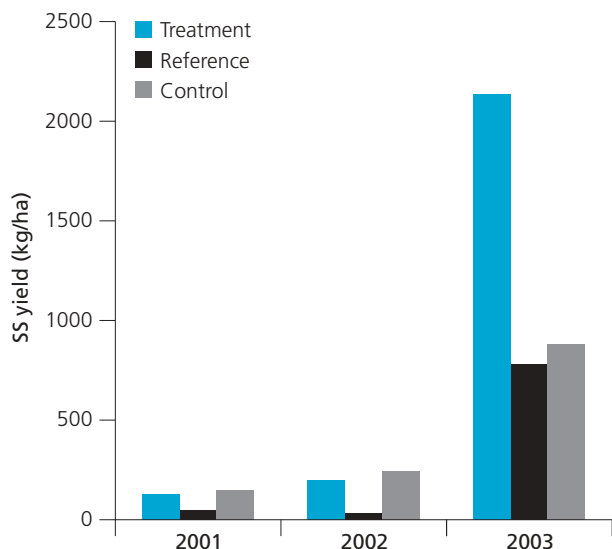
**Figure 6.23.** Total suspended sediment yield for Echidna Creek, showing that the increase in yield from the treatment stream relative to the control and reference sites.

Why did revegetation lead to this initial dramatic increase in sediment yield? The revegetation process required the removal of existing invasive pasture grass, ground cover and woody weeds. This ground cover was killed by herbicide before the new vegetation was

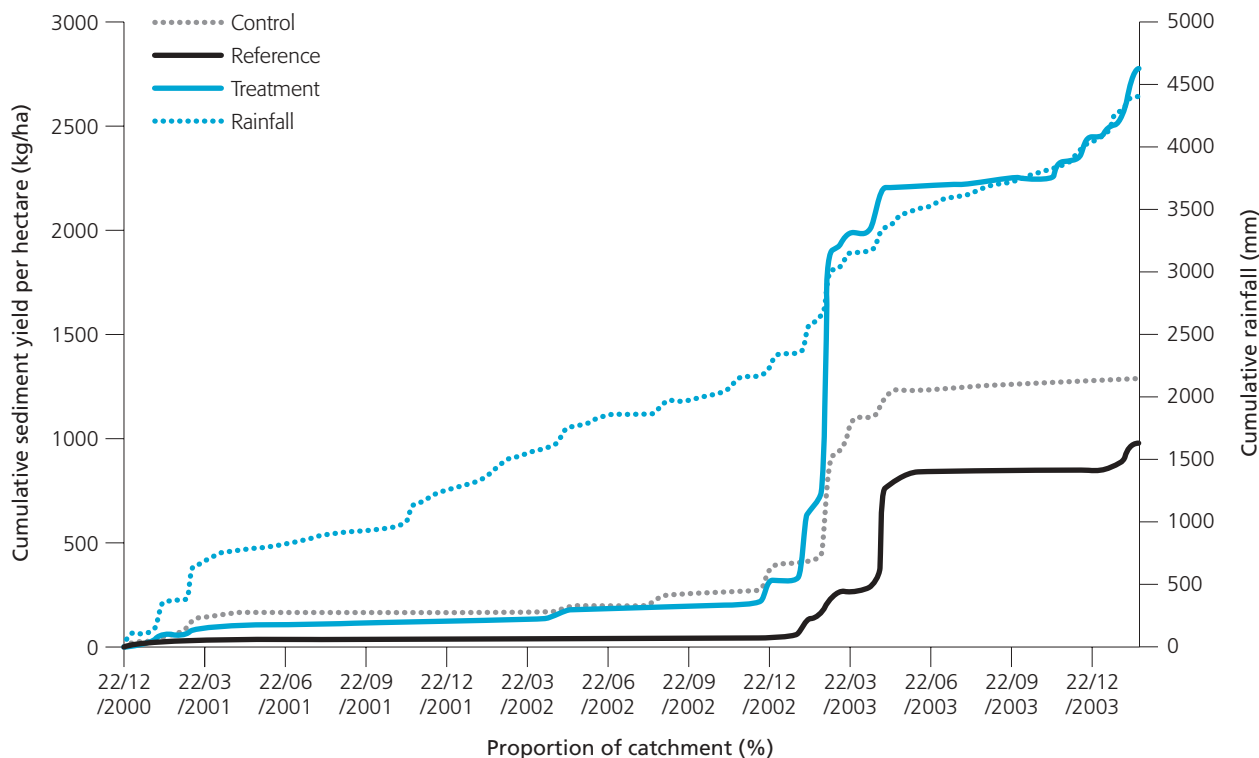
**Figure 6.24.** Cumulative suspended sediment yield per effective catchment area for the control, reference and treatment catchments.

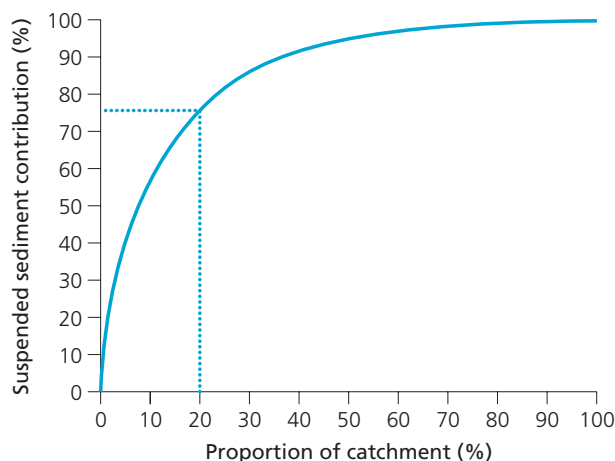
**Figure 6.25.** Cumulative sediment yield plotted against proportion of total area for catchments of the Murray Darling Basin (data from Sednet modelling). Note that nearly 80% of the sediment comes from only 20% of the catchment area.
